Uniform Mitigation Verification Inspection Form

Inspection Date: 08/10/2018		
Owner Information		
Owner Name: Spanish Pines Condo Association		Contact Person: Costas Papachristos
Address: 131 Cypress Way East		Home Phone:
City: Naples	Zip: 34110	Work Phone:
County: COLLIER		Cell Phone:
Insurance Company:		Policy #:
Year of Home: 1981	# of Stories: 2	Email:

8/10/2018 Front
Spanish Pines Condominium Association:
131 Cypress Way E Bldg 131 Naples built 1981

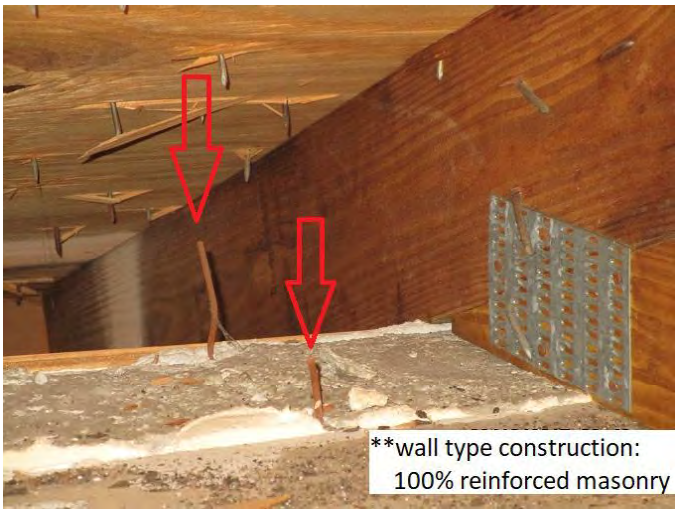
Bldg 131- right elevation
#5) roof geometry: HIP style roof
**wall type construction: 100% reinforced masonry

**wall type construction: 100% reinforced masonry

**wall type construction:
100% reinforced masonry

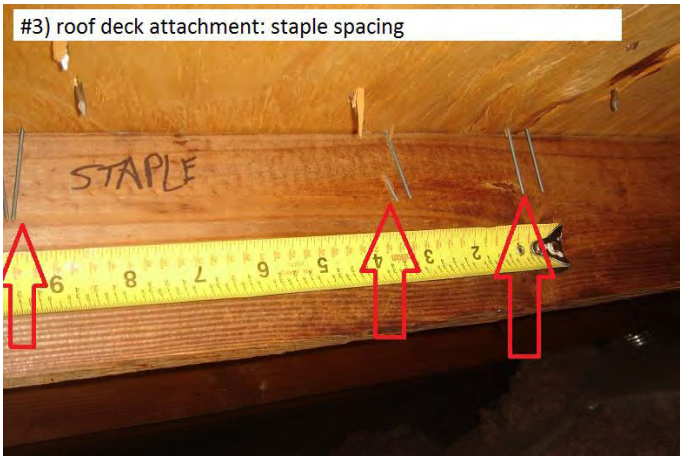
#3) roof deck attachment: staples

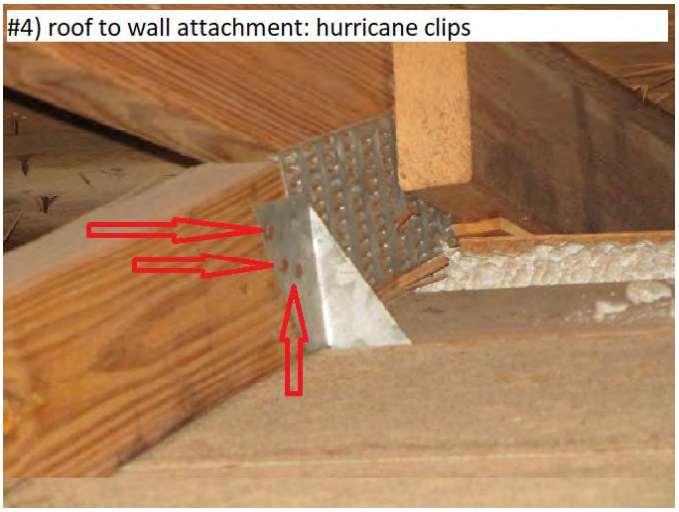
#4) roof to wall attachment: hurricane clips
